Project **170879**
 Drawn By: AMF
 Checked By: RLM

TOPOGRAPHIC SURVEY
 A PORTION OF
 J R BELL SURVEY, ABSTRACT NO. 113123
 CITY OF DALLAS, DALLAS COUNTY, TEXAS

SITE NAME:
 Dallas, TX
 (Home Depot 547)

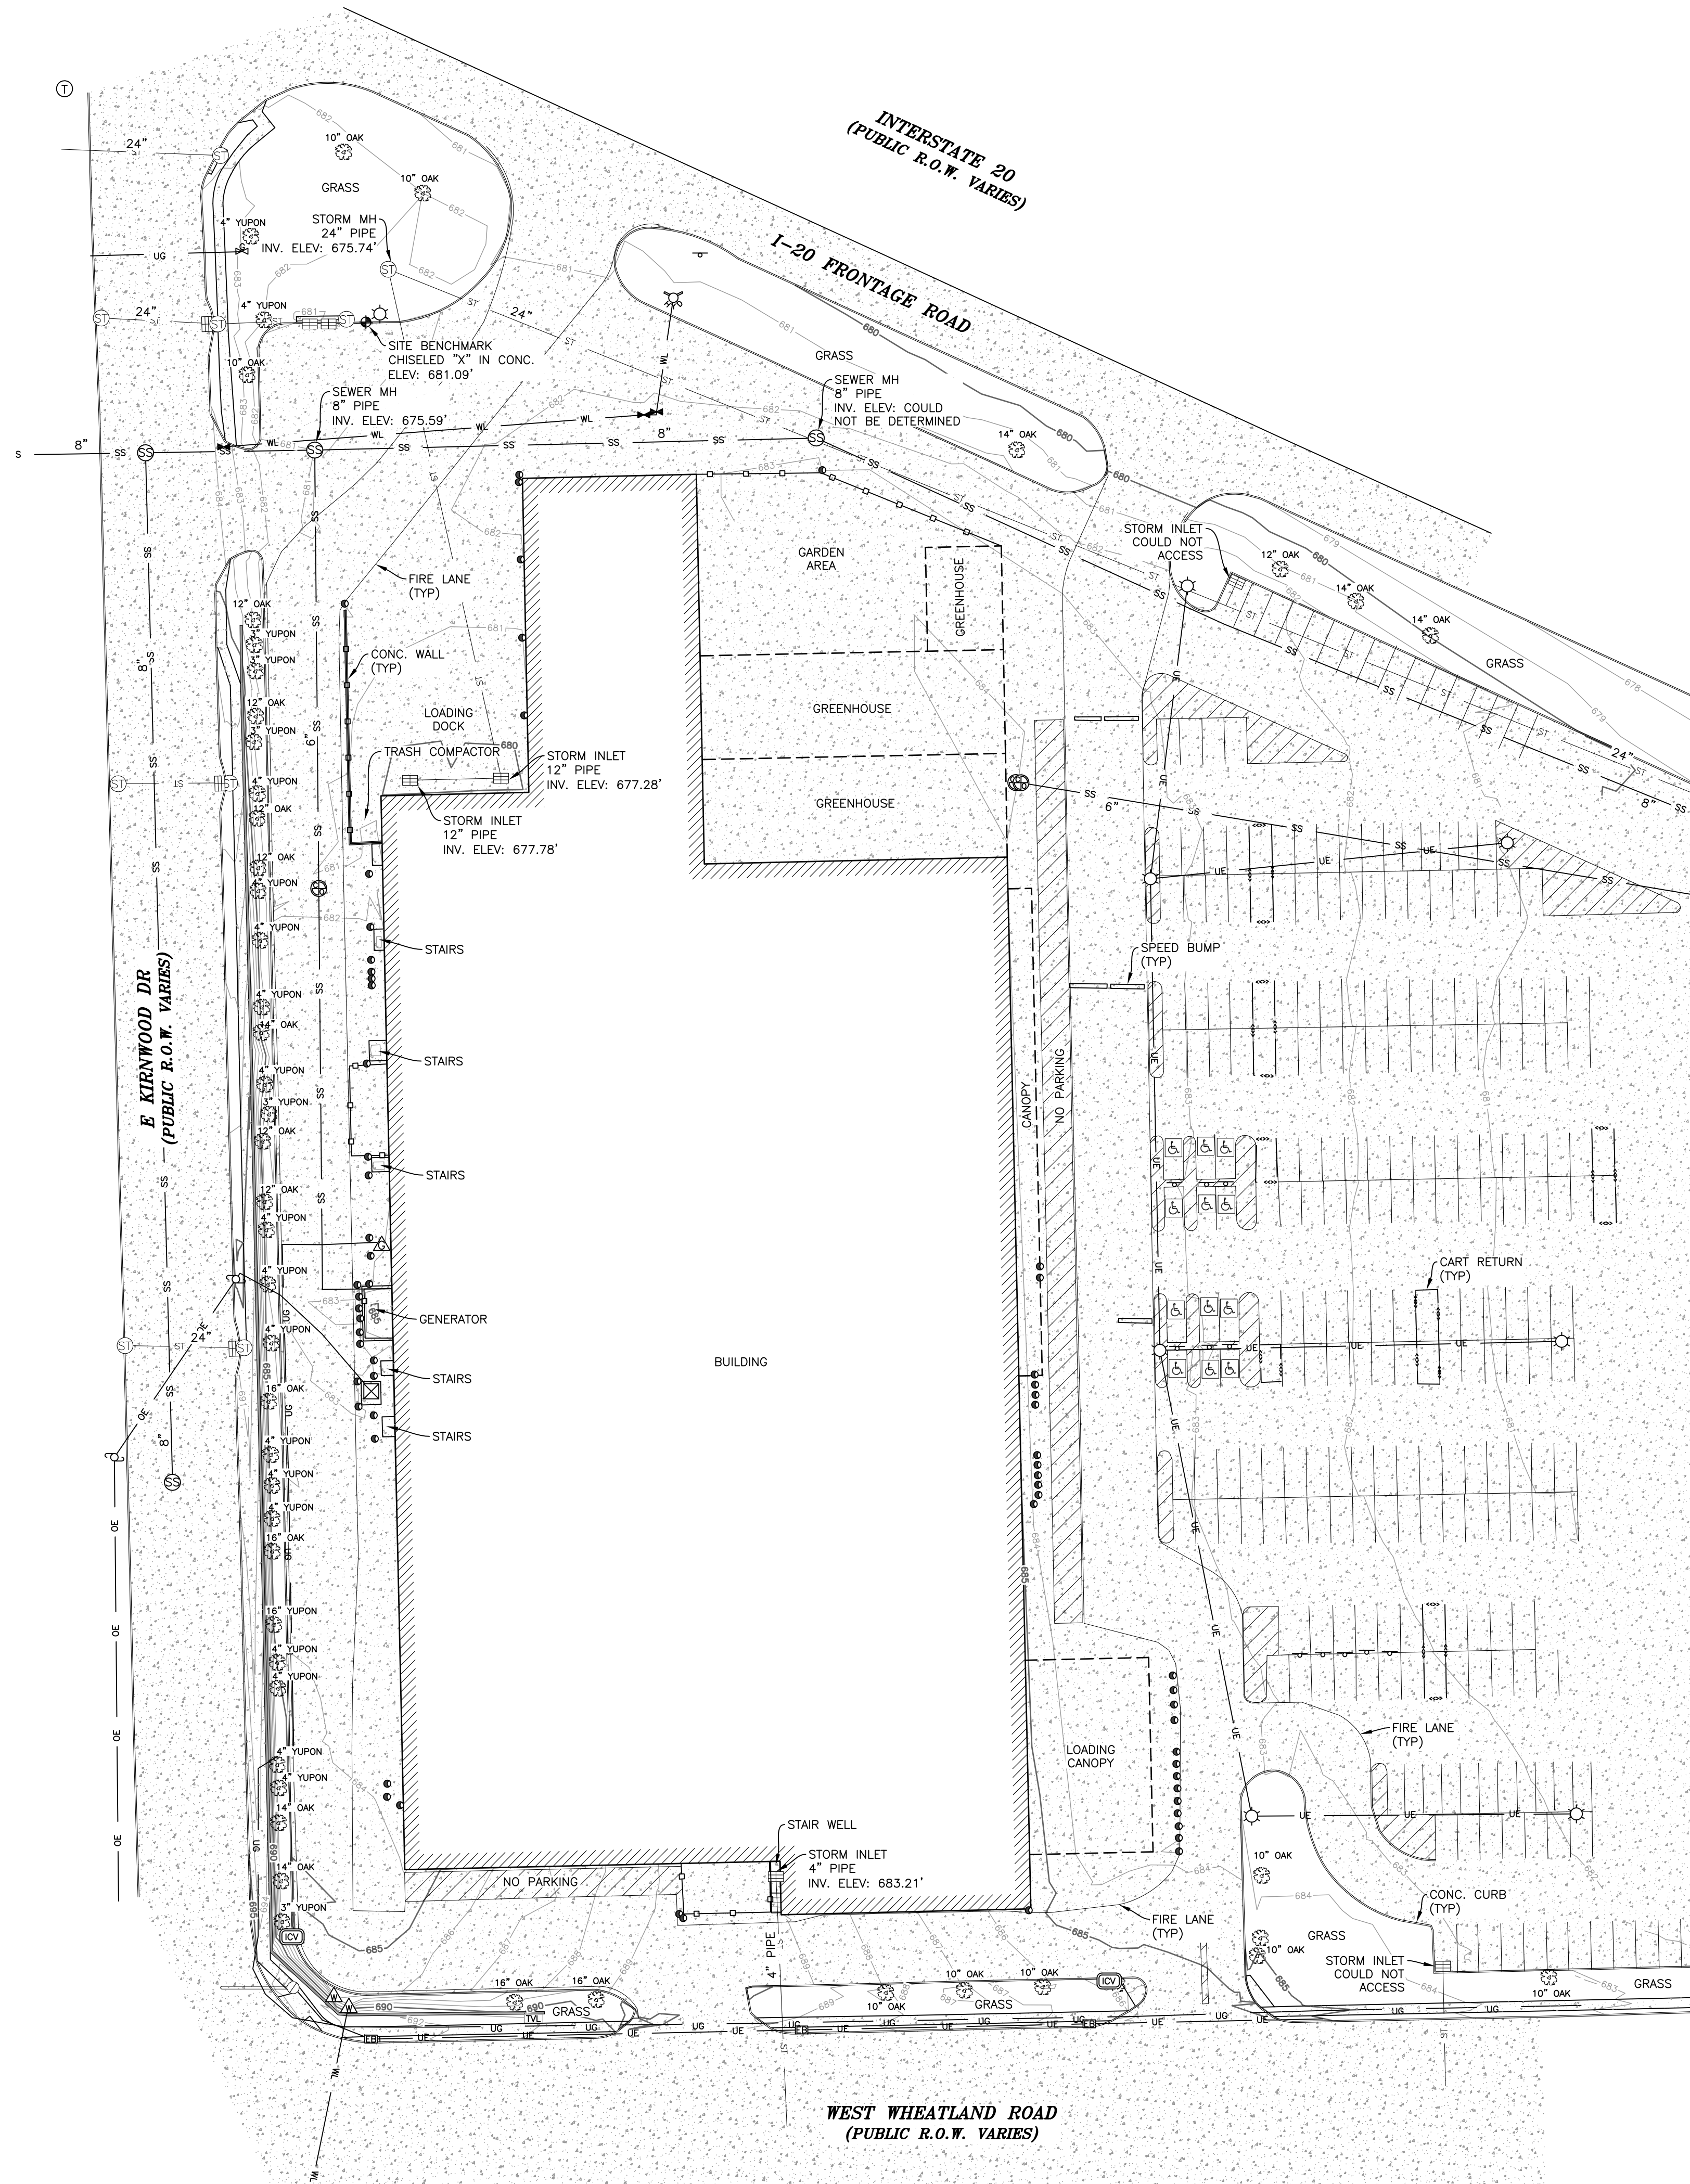
1. This is a topographic map. It is not a Land Survey Plat or Improvement Survey Plat. No research of easements, encumbrances or title of record was performed Clark Land surveying Inc.

2. Any underground utilities shown have been located from field survey information and utility locate markings. The surveyor makes no guarantee that the underground utilities shown comprise all such utilities in the area, either in service or abandoned. The surveyor further does not warrant that the underground utilities shown are in the exact location indicated although he does certify that they are located as accurately as possible from the information available. This surveyor has not physically located the underground utilities.

3. BENCHMARK: Chiseled "X" in concrete. Elevation = 681.09' (NAVD 88).
4. Field work for this survey was completed on December 12, 2017
5. BASIS OF BEARINGS: Survey is referenced to Texas State Plane, 4202-Texas North Central Zone.
